TEST REPORT

REPORT NO. : S-1066

PROJECT : **Standard**

TYPE OF TEST : **Single Shear Test**

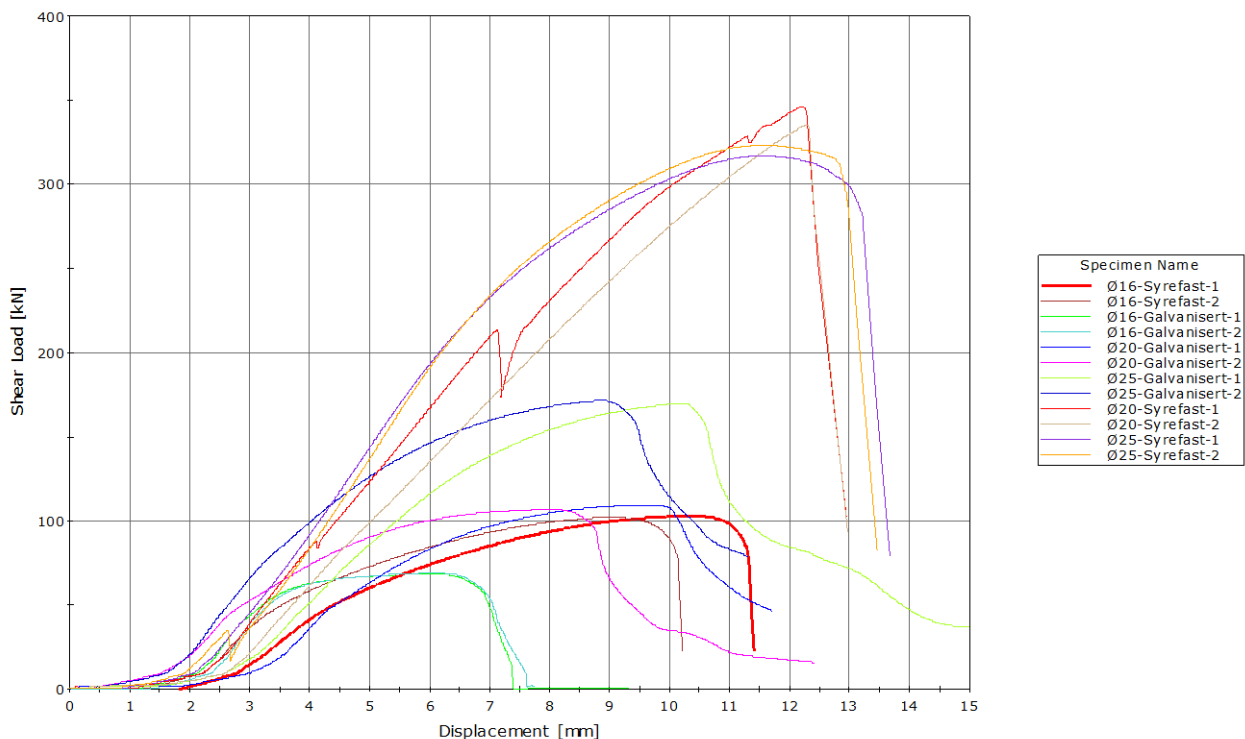
Single shear test

Comment: The graph for Ø20-Syrefast-1 have some disturbance because two fixture support bolts went to fracture. These bolts are not relevant for the test and merely was attached to maintain centering in the grip section away from the actual test area. the centering was unaffected by the fracture due to the high clamping force in the machine grips.

Sample	Dimension	Shear load [kN]	Displacement [mm]	Rate [mm/min]
Ø16-Syrefast-1	Ø16	102,6	10,32	10
Ø16-Syrefast-2	Ø16	102,0	9,05	10
Ø16-Galvanisert-1	Ø16	68,3	6,00	10
Ø16-Galvanisert-2	Ø16	68,7	6,07	10
Ø20-Galvanisert-1	Ø20	109,2	9,65	10
Ø20-Galvanisert-2	Ø20	106,8	8,00	10
Ø25-Galvanisert-1	Ø25	169,6	10,19	10
Ø25-Galvanisert-2	Ø25	171,3	8,91	10
Ø20-Syrefast-1	Ø20	345,9	12,22	10
Ø20-Syrefast-2	Ø20	335,7	12,29	10
Ø25-Syrefast-1	Ø25	317,2	11,50	10
Ø25-Syrefast-2	Ø25	323,4	11,56	10
